# CASE STUDY

### HIGH FREQUENCY INFLUENCE ON THE DRIVE SYSTEM OF A DETACHABLE CHAIRLIFT AT OBERSTDORF OK MOUNTAIN RAILWAYS - GERMANY

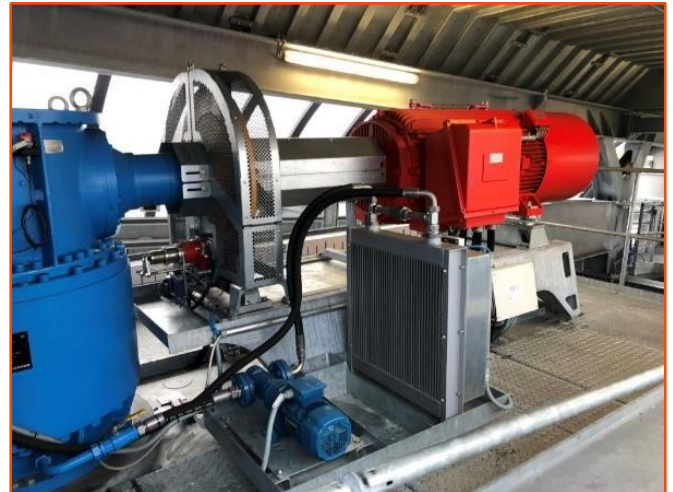
Leitner rope way overhead drive

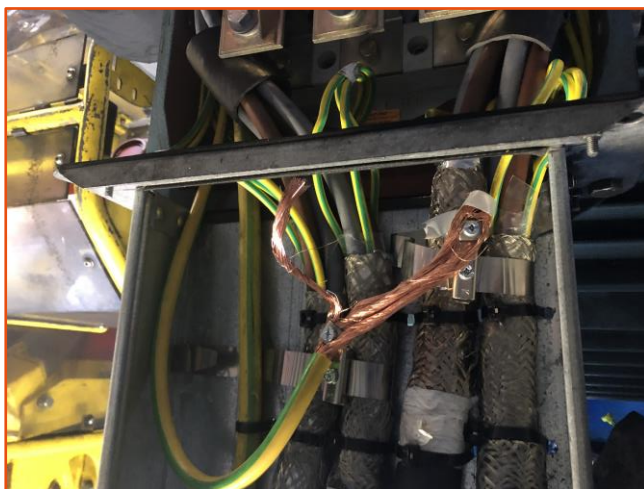
After overall system inspection, analysis and high-frequency measurement, it appeared that the existing grounding system was not designed for HF-Influence.

Existing grounding system

The Mersen’s team performed technical support for the improvement of the earthing system and the installation of damping cores.

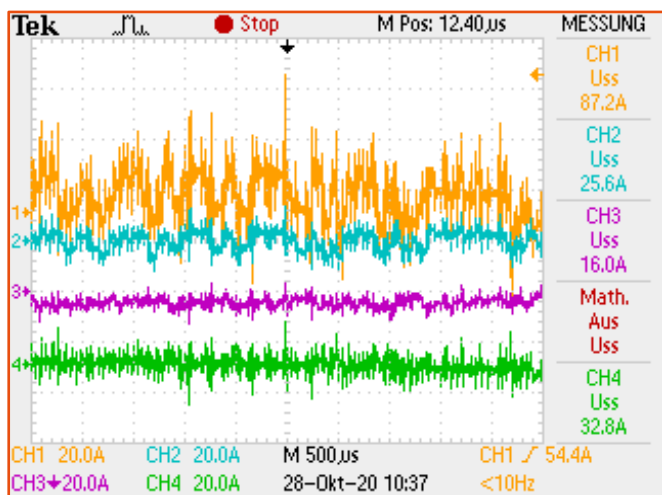
Result of the HF measurements without damping cores

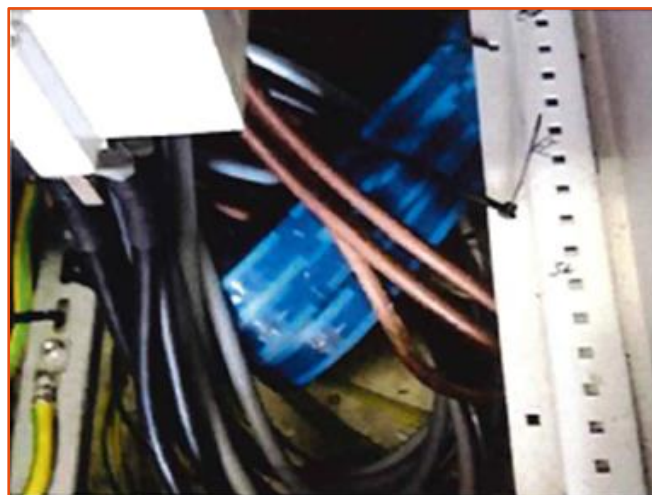
Damping cores installed

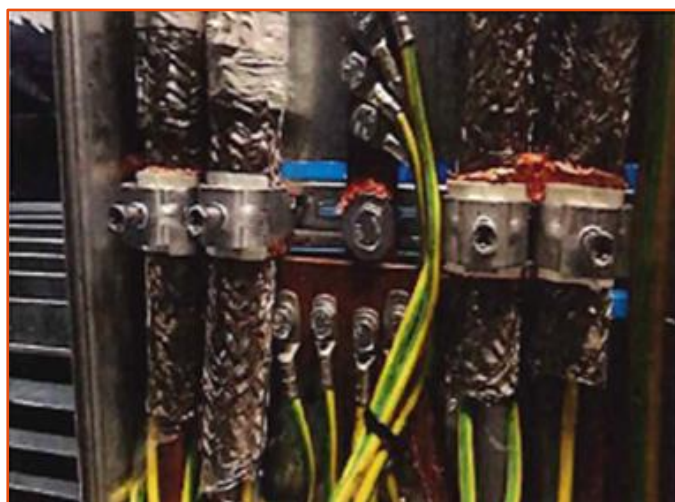
Earthing system improved for HF-Influence

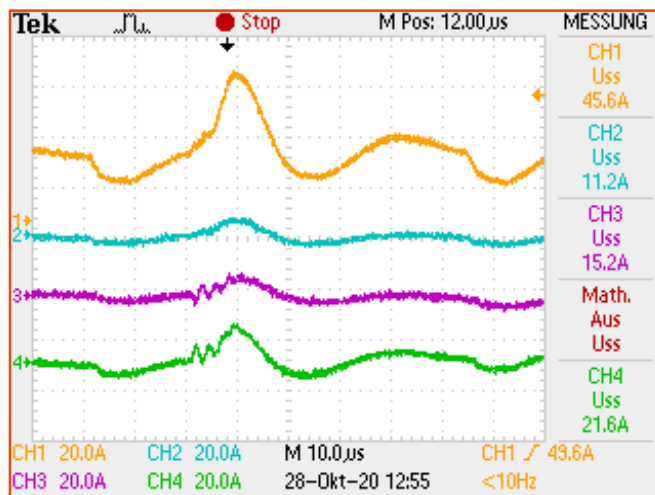
Result of the HF measurements with damping cores

After the system check by Mersen, the installation of the damping cores and the improvement of the earthing system, the problems are solved.
